\*\*\*\*\* HOME INSPECTION REPORT \*\*\*\*\*

1 Townhouse Way  
Livingston, NJ  
Prepared for: Ms. Jane Who

RE: 1 Townhouse Way  
Livingston, NJ 07039

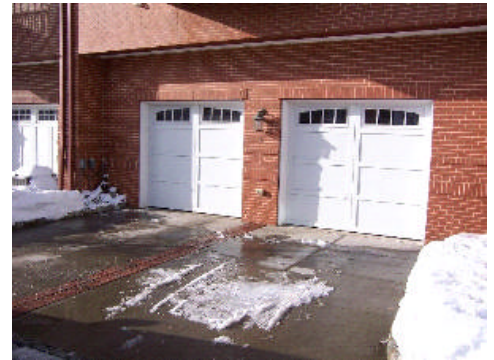
LOCATION: Built-In, two car.

GARAGE-CARPORT Garage.

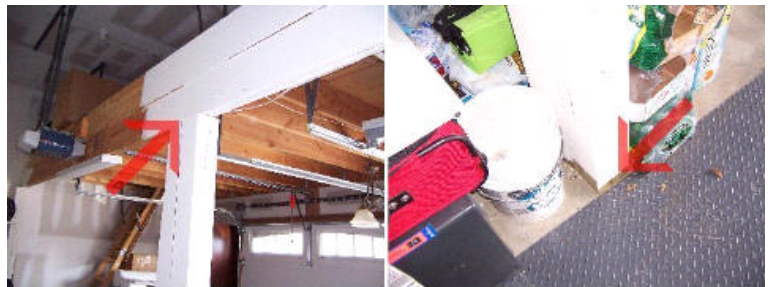
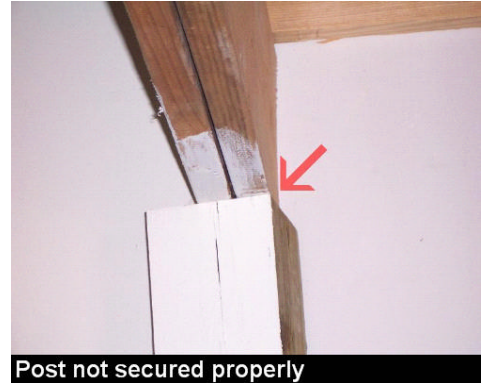
There are structural concerns with the loft area built in the garage. The wood posts supporting the loft are missing the proper post to beam connectors and the posts are not secured properly to a footing on the slab floor. The wood posts have several cracks/checks in the wood. Prior to closing it is necessary for you to obtain further evaluation by a

qualified, licensed, and insured contractor to define the scope and cost of the necessary corrective action. This is a safety concern.

There are structural concerns with the loft area built in the garage. The wood posts supporting the loft are missing the proper post to beam connectors and the posts are not secured properly to a footing on the slab floor. The wood posts have several cracks/checks in the wood. Prior to closing it is necessary for you to obtain further evaluation by a qualified, licensed, and insured contractor to define the scope and cost of the necessary corrective action. This is a safety concern.

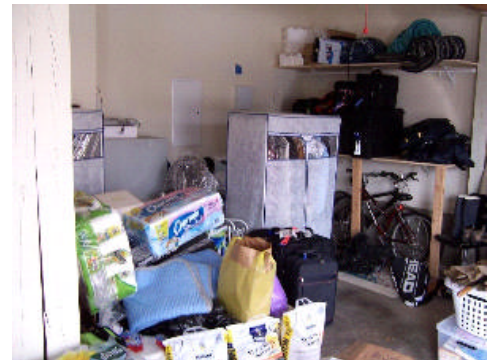
**INTERIOR WALL MATERIAL/CONDITION:** Drywall, fire rating not known. Visible areas serviceable. Considerable clutter/storage items in this area. Garage not fully visible.

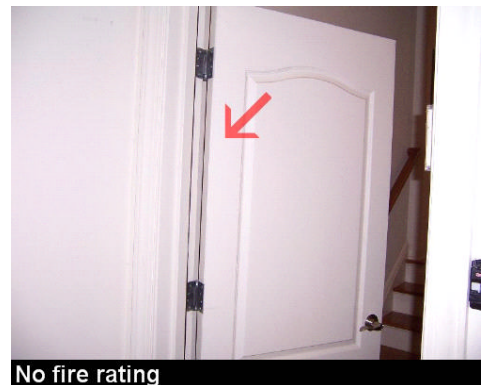
**PEOPLE DOOR TO INTERIOR:** Door has no fire rating. Recommend installing a door with a 20-minute fire rating or 1-3/8in solid core door. This is a FIRE AND SAFETY HAZARD.

Door has no fire rating. Recommend installing a door with a 20-minute fire rating or 1-3/8in solid core door. This is a FIRE AND SAFETY HAZARD.

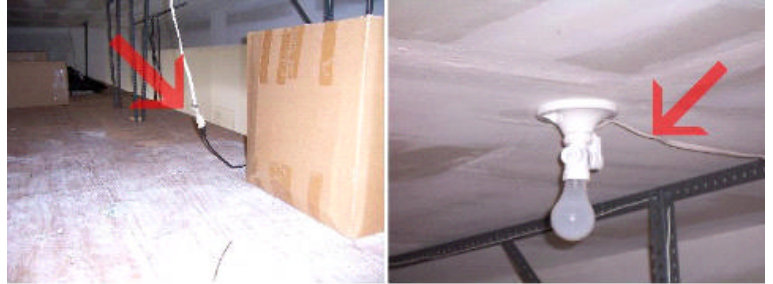
GFI (ground fault interrupter) outlets are required in garages as a safety concern. GFI outlets are installed and serviceable. Noted lamp wire and/or extension cord wire used. This does not meet today's standards. Recommend installing additional outlets if needed. This is a fire and safety concern. Garage ceiling light is an exposed light bulb. Recommend replacing exposed bulb with a covered bulb type light fixture to protect the light bulbs. This is a FIRE AND SAFETY CONCERN.

GFI (ground fault interrupter) outlets are required in garages as a safety concern. GFI outlets are installed and serviceable. Noted lamp wire and/or extension cord wire used. This does not meet today's standards. Recommend installing additional outlets if needed. This is a fire and safety concern. Garage ceiling light is an exposed light bulb. Recommend replacing exposed bulb with a covered bulb type light fixture to protect the light bulbs. This is a FIRE AND SAFETY CONCERN.

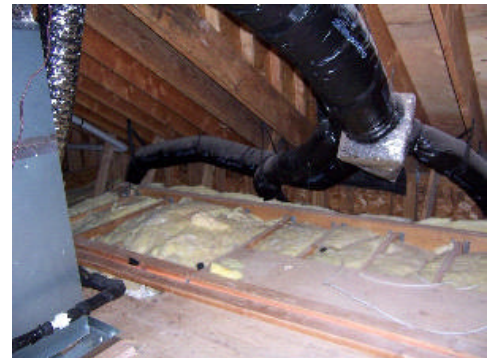
**ATTIC ACCESS:** Wall scuttle hole through the bedroom. Entered and inspected the unfinished part of the attic.

- METHOD OF INSPECTION:** Much of this attic is finished and used as a living space. There is limited viewing of the rough framing in this area. I was not able to view much of the structure, insulation, mechanical, or venting components of the attic in the finished area. In addition to these items, I was not able to verify the presence of current or past roof leaks or any resulting damage.
- ROOF SHEATHING:** Plywood where visible.
- WALL SHEATHING:** Not visible.
- FRAMING/STRUCTURE:** Standard dimensional lumber.
- RAFTER SYSTEM:** 2x12's 16 inches on center.
- COLLAR TIES:** Serviceable.
- JOISTS:** Not fully visible. Insulation prevents viewing of floor joists.

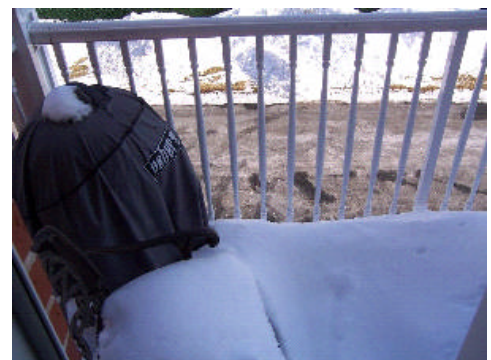
**GENERAL CONDITION:** Serviceable. Snow cover prevents viewing deck boards.

**GUARDRAILS:** Guardrail(s) serviceable.

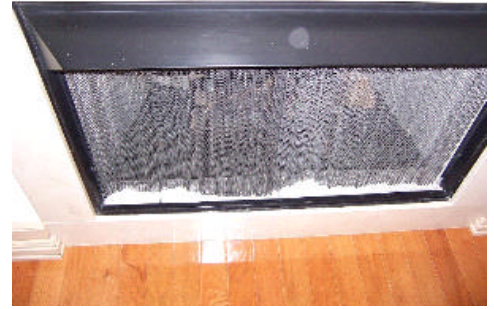
**TYPE OF UNIT:** Gas fired non vented. Verify installation as per manufacturers specifications prior to use. Recommend obtaining the user guide for information on operating this unit.

**OVERALL CONDITION:** Unit not tested. Pilot off. Recommend testing prior to closing.  
**TYPE OF FUEL:** Gas.  
**GAS SHUT OFF:** A gas shut off Dante type valve adjacent to the fireplace as an emergency shut off is installed.  
**FIREBOX CONDITION:** Serviceable.  
**FIRE SCREEN:** The recommended safety screen is installed.  
**COMBUSTIBLE CLEARANCE:** Check manufactures specifications for proper clearances.

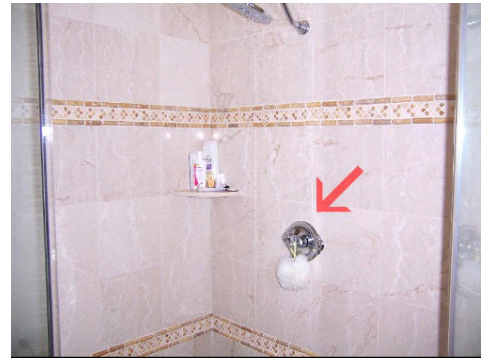
No cold water noted in the shower. Recommend repairs by a licensed and insured plumber.

No cold water noted in the shower. Recommend repairs by a licensed and insured plumber.

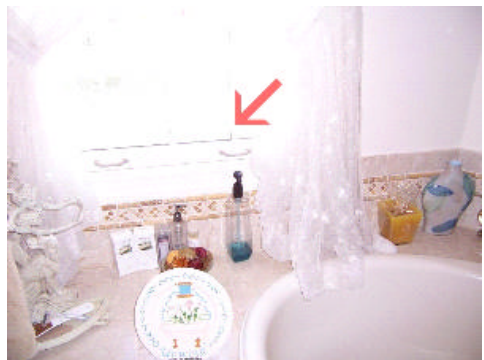
Window located in the tub area. This window should be tempered glass if it is within 5' of the base of the tub/shower or it does not meet today's SAFETY STANDARDS. Recommend an upgrade.

Window located in the tub area. This window should be tempered glass if it is within 5' of the base of the tub/shower or it does not meet today's SAFETY STANDARDS. Recommend an upgrade.

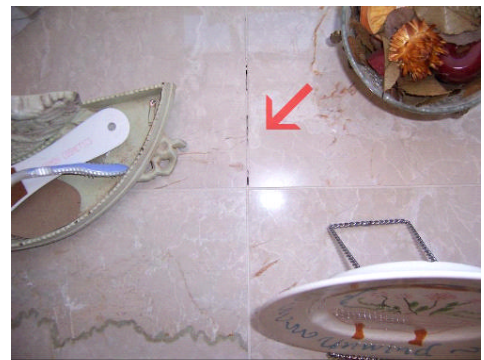
Re grout

Re-grouting is needed in a few areas around the tub to prevent water intrusion.

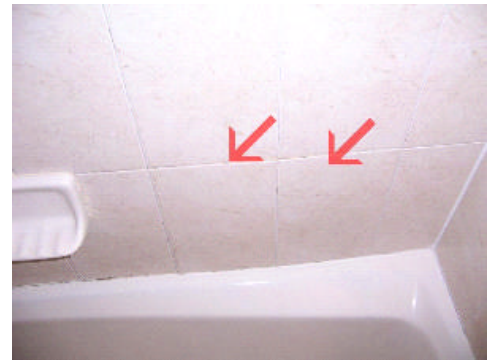
*BATH LOCATION:* Hall, 4th floor.  
*FIXTURES:* Toilet, Sink, Bath tub with shower.  
*CONDITION OF SINK(S):* Serviceable.  
*CONDITION OF TOILET:* Serviceable.  
*TUB/SHOWER PLUMBING FIXTURES:* Serviceable.  
*TUB/SHOWER AREAS:* A few loose/bulging tiles noted in tub/shower area. Recommend repair loose tiles to prevent water intrusion and damage.

A few loose/bulging tiles noted in tub/shower area. Recommend repair loose tiles to prevent water intrusion and damage.

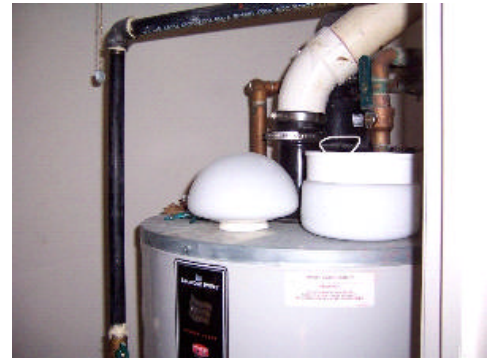
*TYPE:* Gas.

<i>SIZE:</i>	75 Gallons.
<i>LOCATION:</i>	Closet.
<i>APPROXIMATE AGE:</i>	Newer unit. Less than 3 years old.

*VISUAL CONDITION:* Serviceable.  
*VENT CONDITION/  
 CLEARANCE TO  
 COMBUSTIBLES:* Within standards.  
*GAS SUPPLY LINE:* Shut off and drip leg in place.  
*TEMP/PRES RELIEF VALVE:* Temperature/Pressure relief valve and discharge pipe noted, not tested.  
*FLOOR DRAIN/DRIP PAN:* Yes, floor drain and drip pan installed.

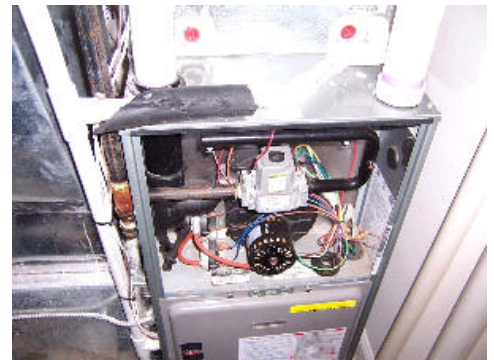
*HEATING AREA:* Basement, lower floors.  
*LOCATION OF UNIT:* Basement.

*BRAND:* Weather King.  
*SYSTEM TYPE:* Induced draft hot air furnace.

*NET CAPACITY/OUTPUT (approx.)* 80 thousand btu's.

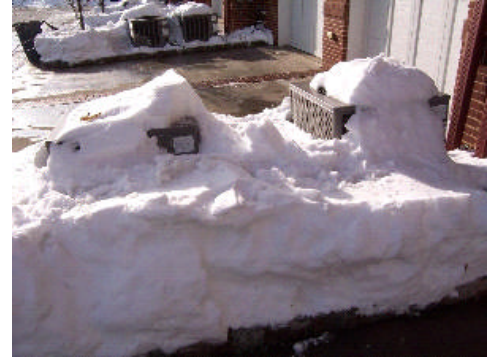
**CONDENSER UNIT:** The compressor units are not on a level pad. It is recommended that the units be re-leveled to help prolong the units lifespan.

The compressor units are not on a level pad. It is recommended that the units be re-leveled to help prolong the units lifespan.

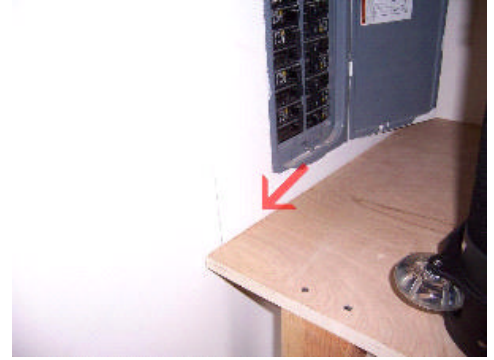
Installed wall shelving prevented removing the panel cover. The service panel is not easily accessible. As a general rule, the panel should be mounted at eye level and should be easily accessible. The area 30 inches to 3 feet in front of the panel should not be obstructed. Recommend correction.

Installed wall shelving prevented removing the panel cover. The service panel is not easily accessible. As a general rule, the panel should be mounted at eye level and should be easily accessible. The area 30 inches to 3 feet in front of the panel should not be obstructed. Recommend correction.

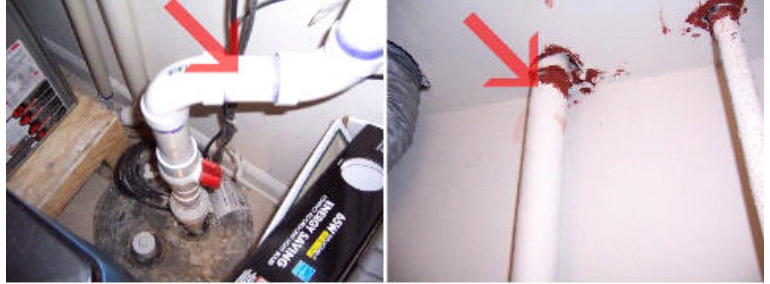
Operational at time of inspection. Discharge pipe bangs against ceiling when pump shuts off. Recommend further evaluation by a licensed plumber to secure pipes and reseal at ceiling.

Operational at time of inspection. Discharge pipe bangs against ceiling when pump shuts off. Recommend further evaluation by a licensed plumber to secure pipes and reseal at ceiling.
